SICHERHEITSMITTEILUNG für Gurtzeuge

Nummer: 2023-02 SM **2023-001** Paraworld – Sife - Klappe

Service Bulletin 2023-001

Subject: Zig zag stitching on main container flap #2

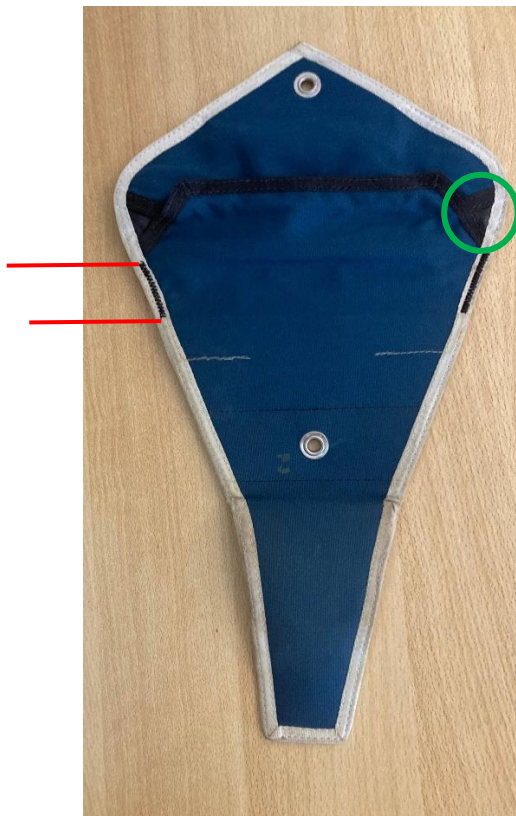
We have been informed that during the activation of the main canopy, one suspension line of the left rear suspension lines caught on the main container flap #2.

Unfortunately, we didn't have the chance to inspect the affected harness and container system to find out the concrete reason why the line was caught on the main container flap #2.

During the pack job the lines had to be laid under the reserve container as described on page 50 in our OWNER MANUAL as **WRONG** and the main canopy had to have a pulling direction which would be due to an unstable body position.

Before the next reserve repack your rigger may strengthen the main container flap #2 with a zig zag stitching as shown on the picture between the two red lines. Start at the end of the binding, where the flap is attached to the reserve container and end at the beginning of the stiffener (red lines in the picture below). Overstitch your zig zag stitching once.

Don't stitch over the two bindings (green circle in the picture below) because there are already two bar tacks under the binding. You don't have to separate the flap from the reserve container while doing the zig zag stitching.
